# VIGO COUNTY SECURITY CENTER

*Repurpose Existing Facility Study*

May 25, 2022

DLZ Indiana, LLC (DLZ)  
2263.1082.90

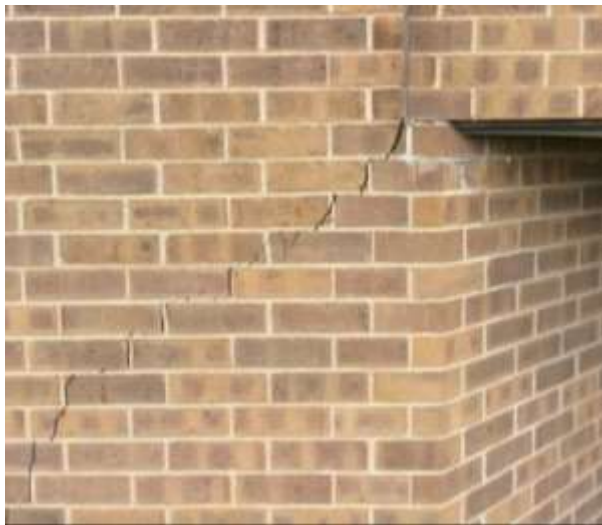
The exterior façade is a brick veneer. The brick veneer is in fair to poor condition due to settlements in the structural foundation system, failures in steel lintels, improper loading on the structure, water infiltration, construction quality, and several other potential issues.

In several areas, there are multiple cracks and separations in the veneer brick. The cracks and separations occur both in a vertical and horizontal shift in the brick veneer. In some instances, the shifts are nearing 1" in change.

Extensive work is recommended to repair the facade issues.

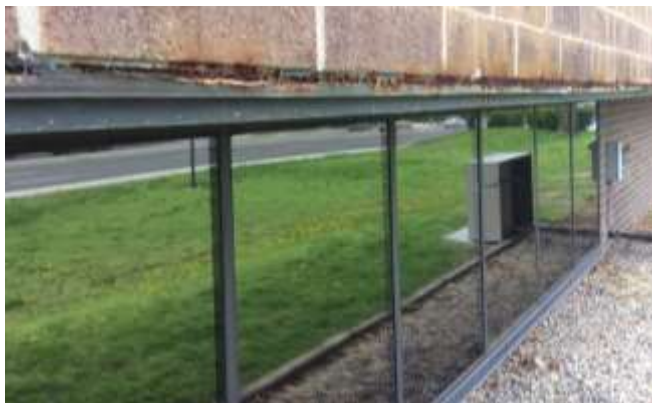
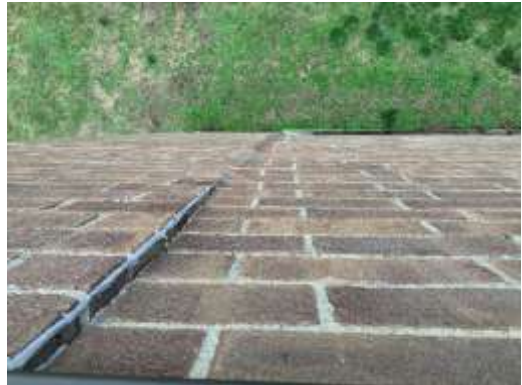
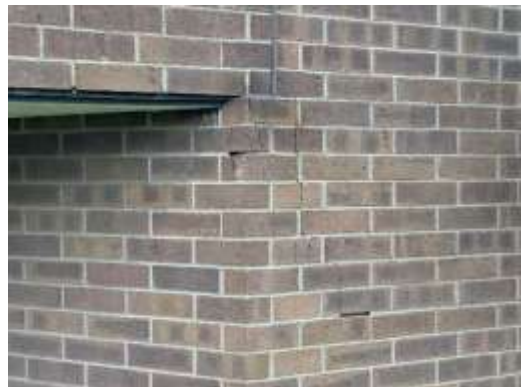
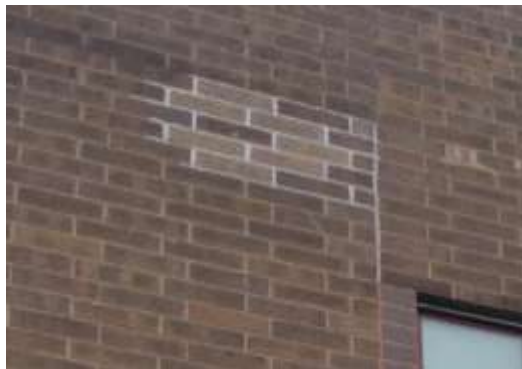
Several areas of the brick veneer have been tuckpointed due to cracks and failures. Mortar color matching is always difficult, as mortar color weathers over the years.

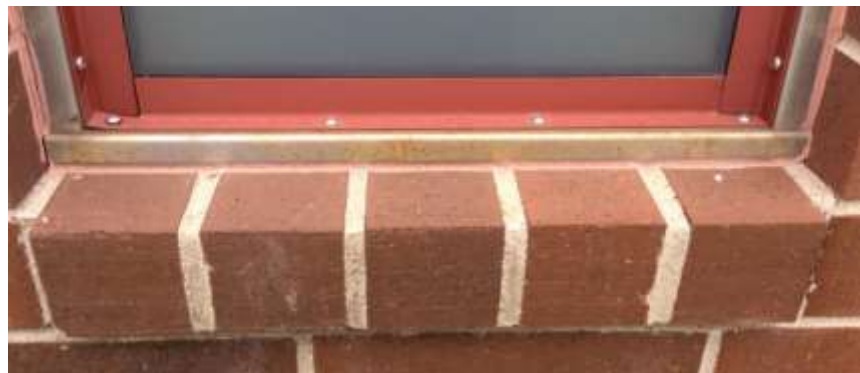
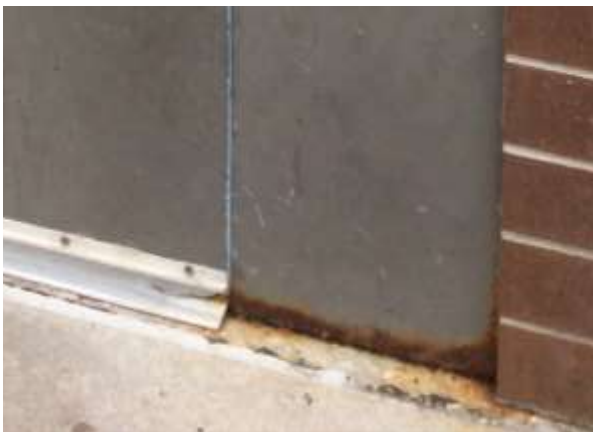
The exterior windows and door systems are in fair condition. There are both commercial grade and detention grade openings around the building, pending the location and internal use. Some windows are showing signs of surface rust.

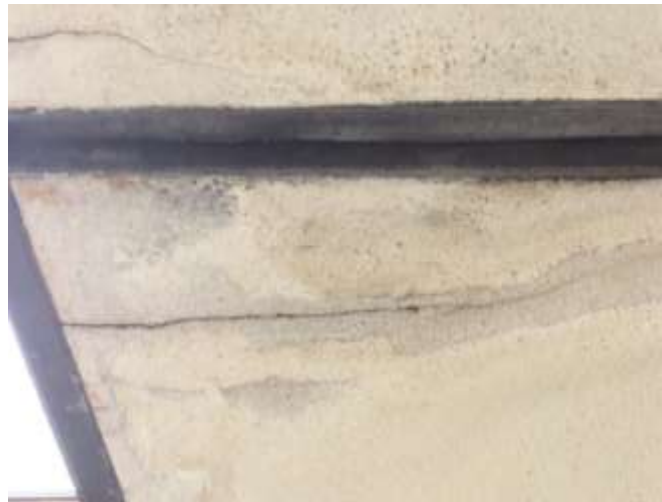
At the soffits, there are several cracks that need repaired. The full soffit needs to be patched, cleaned, and painted.

Additional joints in the soffit are required to control the cracking.

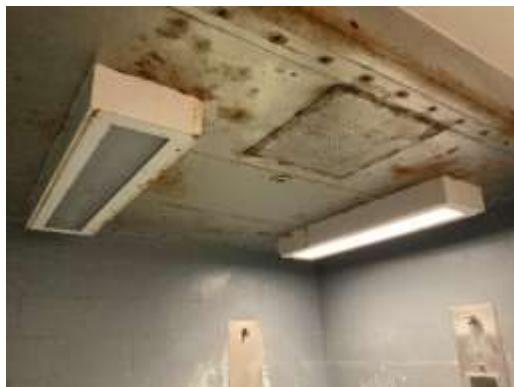
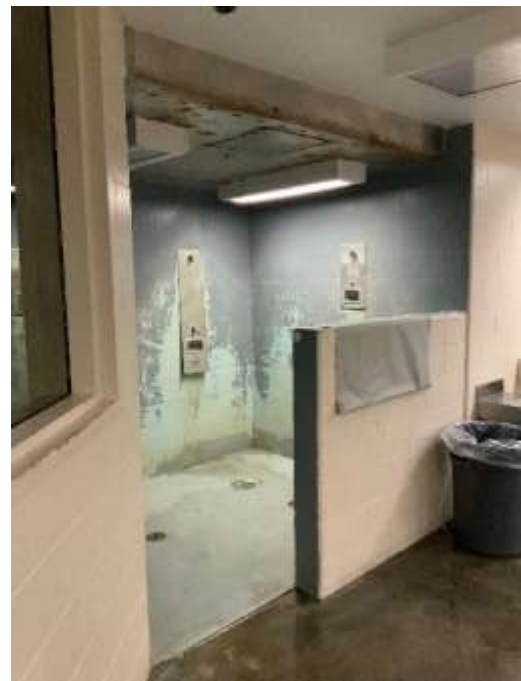
Majority of the shower areas in the Jail are in poor condition. Paint is peeling and metal surfaces have rusted.

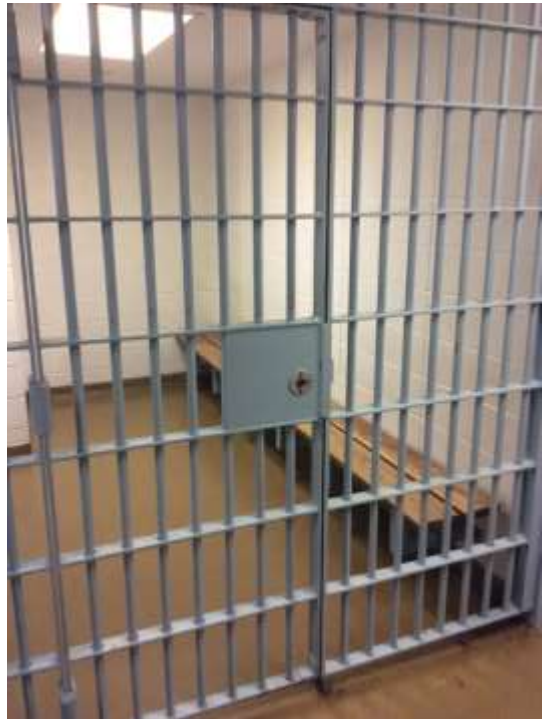
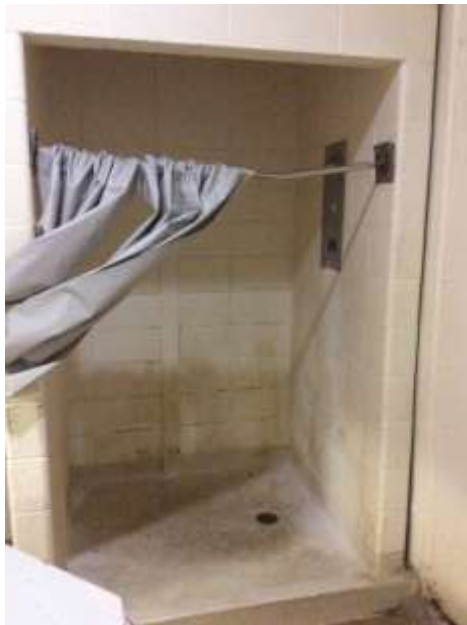
Shower curtain rods at several showers pose a liability threat.

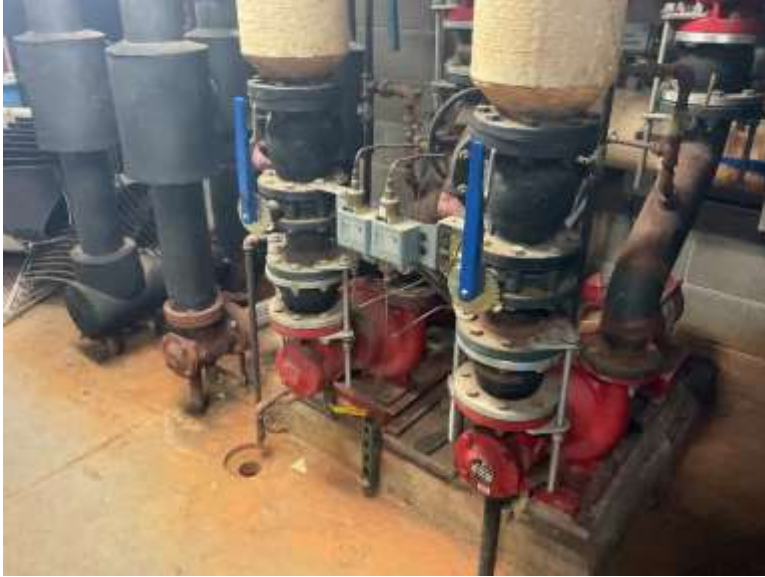
**Photo 3:**

Heating hot water pumps on the left, chilled water pumps on the right. Heating hot water pumps appear to be in better condition and are newer.

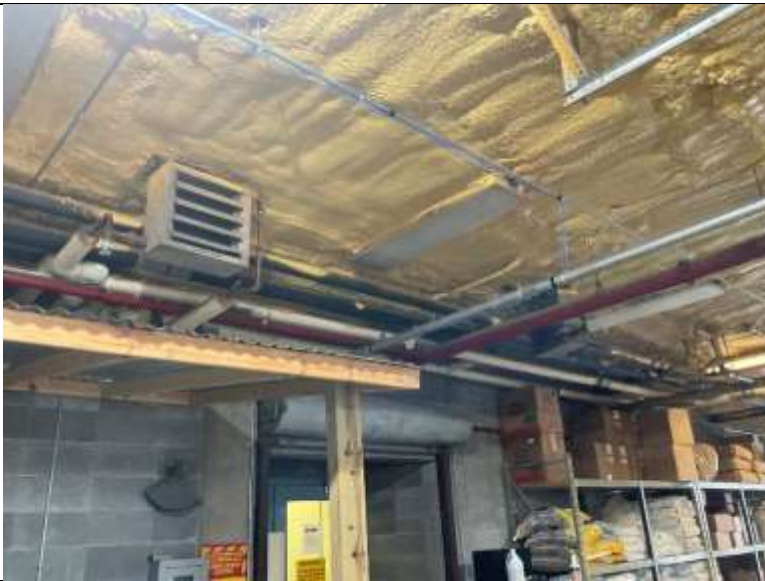
**Photo 4:**

The vehicle sallyport is heated through hot water unit heaters. No vehicle exhaust was observed in the vehicle sallyport. If a vehicle is idled in the space, it could result in the build up of dangerous gases such as carbon monoxide. The space should have a vehicle exhaust fan that is controlled by a CO/NO2 sensor.

Vehicle Sallyport heating by hot water unit heater. No exhaust observed in the area.

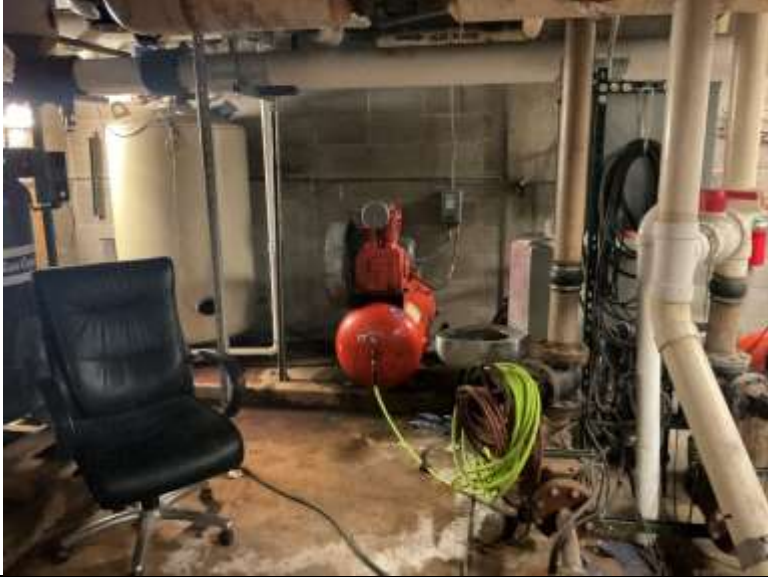
**Photo 5:**

Air Compressor used for pneumatic controls in basement.

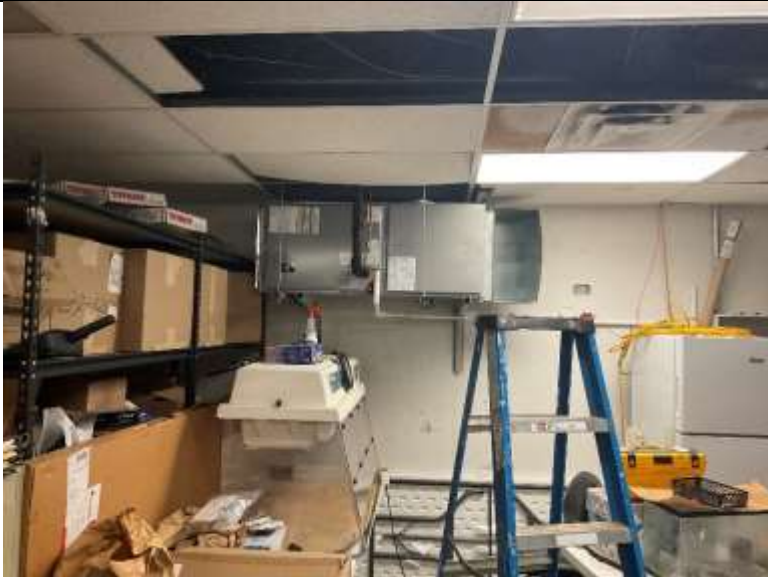
**Photo 6:**

HVAC Unit serving the room with the security electronics equipment. Unit in good condition.

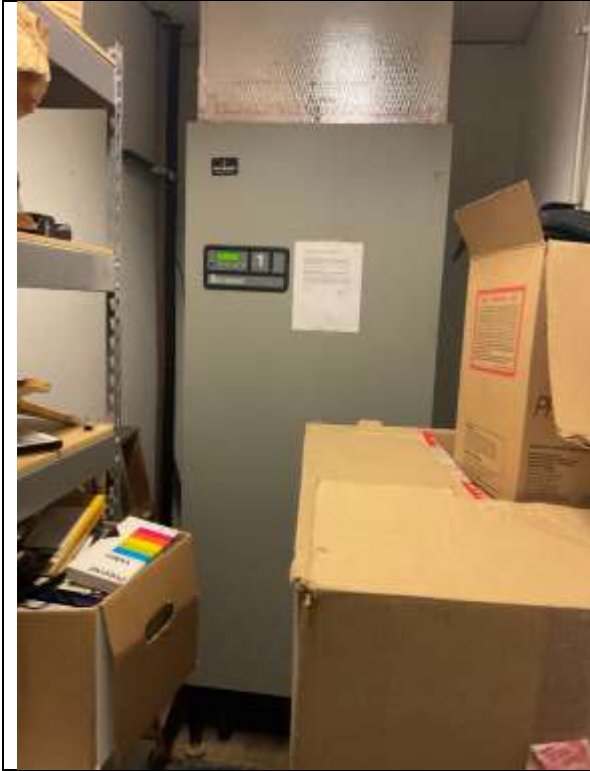
**Photo 7:**

HVAC Unit serving the Dispatch Area distribution system. Unit is in good condition.

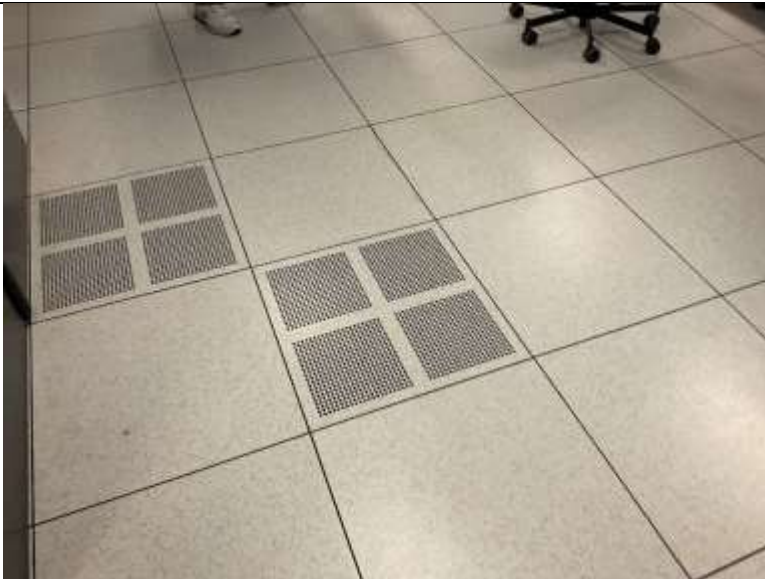
**Photo 8:**

Dispatch Area floor grille that is part of the underfloor HVAC system.

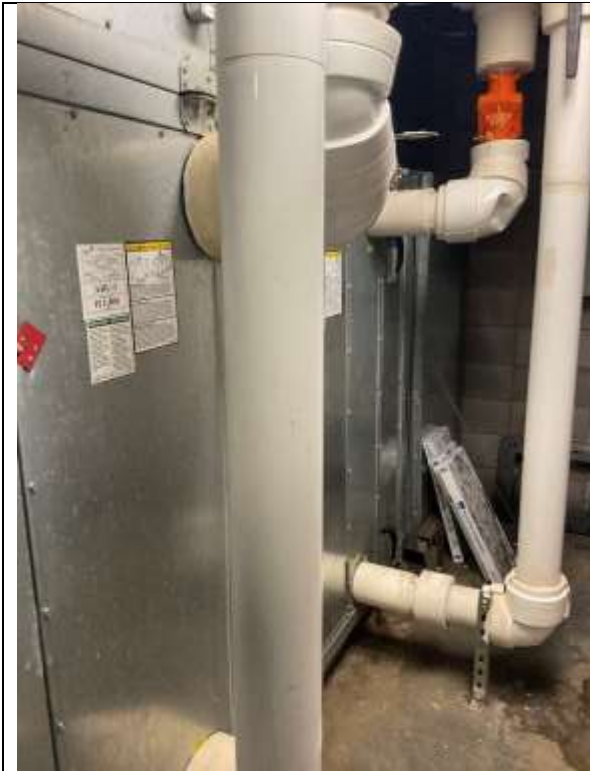
**Photo 9:**

AHU-1 serving the eastern half of the building. Unit installed in 2014 and is in good condition.

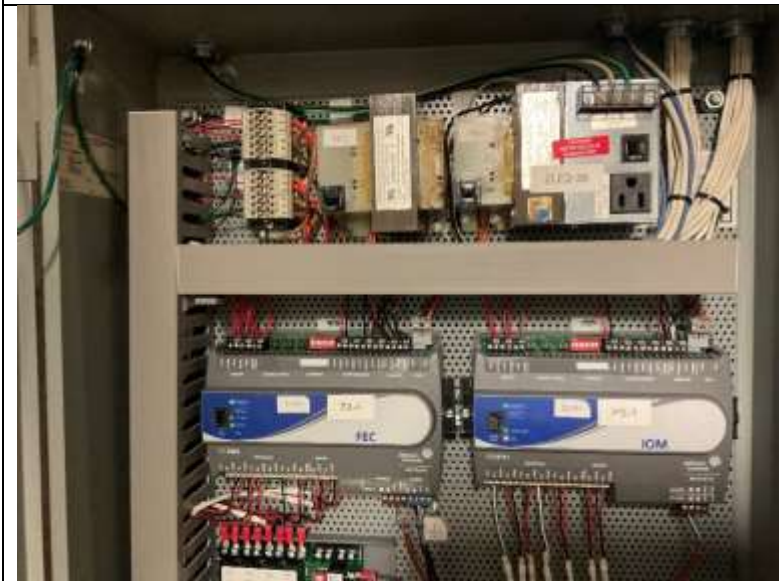
**Photo 10:**

DDC Controls serving AHU-1.

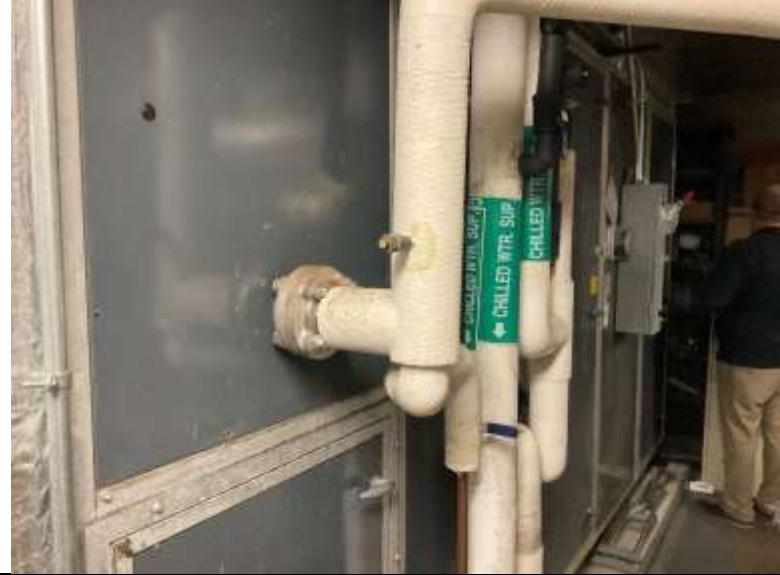
<p><b>Photo 11:</b></p> <p>AHU-2 serving a portion of the 2000 Renovation. Unit is in fair condition but 20 years old.</p>

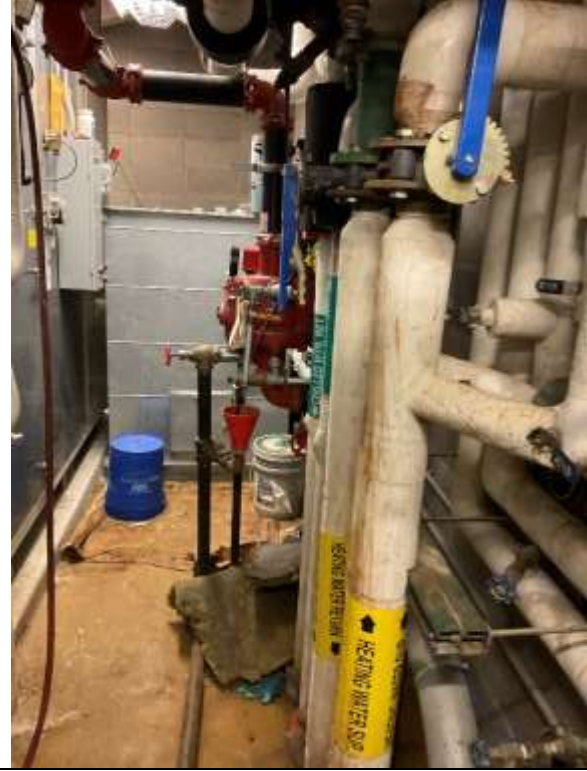
<p><b>Photo 12:</b></p> <p>AHU-3 on the 3<sup>rd</sup> Floor Mechanical Room. AHU is to the left. Dry pipe fire protection system, hydronic piping serving AHU to the right.</p>

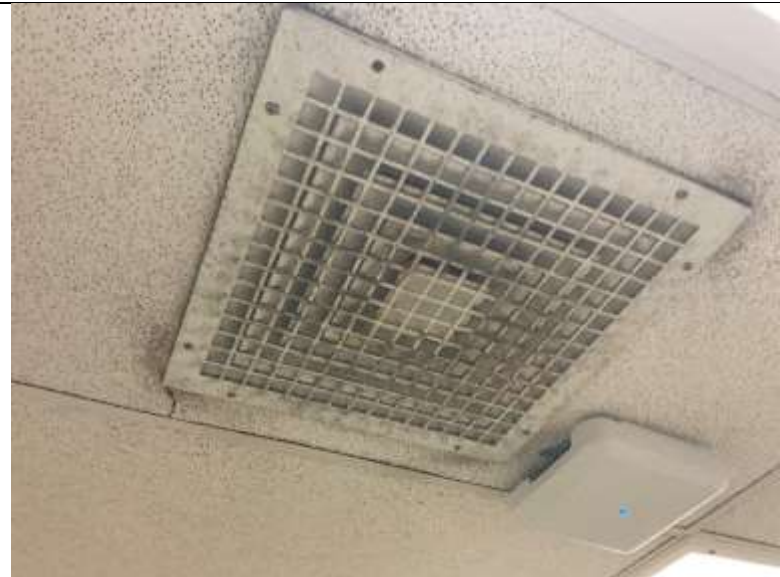
<p><b>Photo 15:</b></p> <p>Typical condition of grilles observed in the 2000 Renovation Housing Pods. Grilles are rusted and dirty.</p>

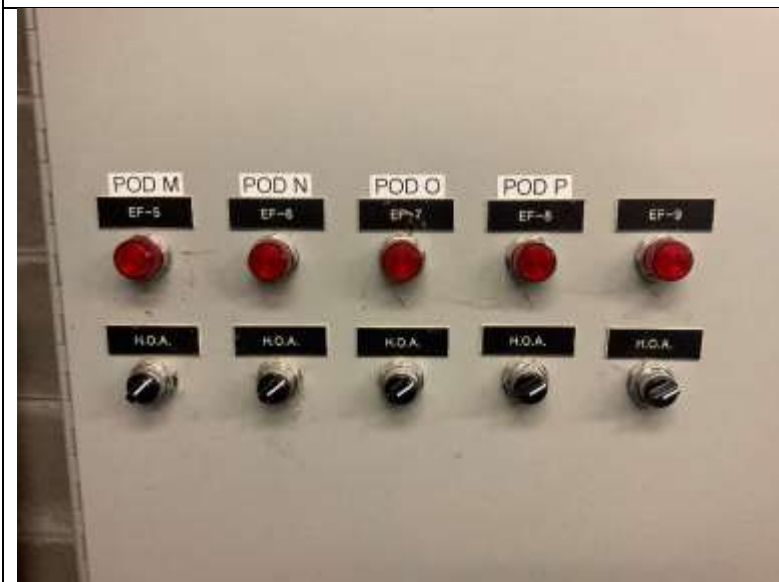
**Photo 17:**

Status panel and Hand-Off-Auto switches for exhaust fans serving housing pods.

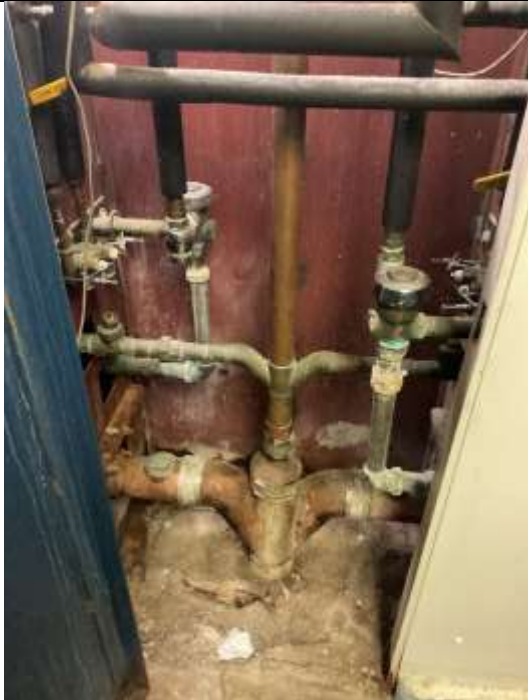
<p><b>Photo 1:</b></p> <p>Intake/Booking Area Chase. These chases have more space than some others. Piping is old.</p>

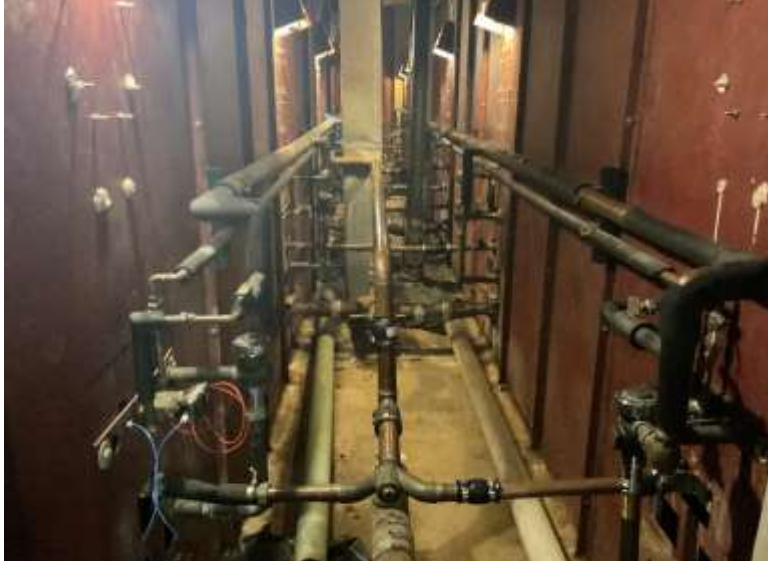
<p><b>Photo 3:</b></p> <p>2<sup>nd</sup> Floor East Housing Pods, chase between two Pods. Requires stepping over and around piping, especially the further back in the chase someone needs to go. Staff has indicated piping has been damaged when trying to get to shutoff valves further in the chase.</p>

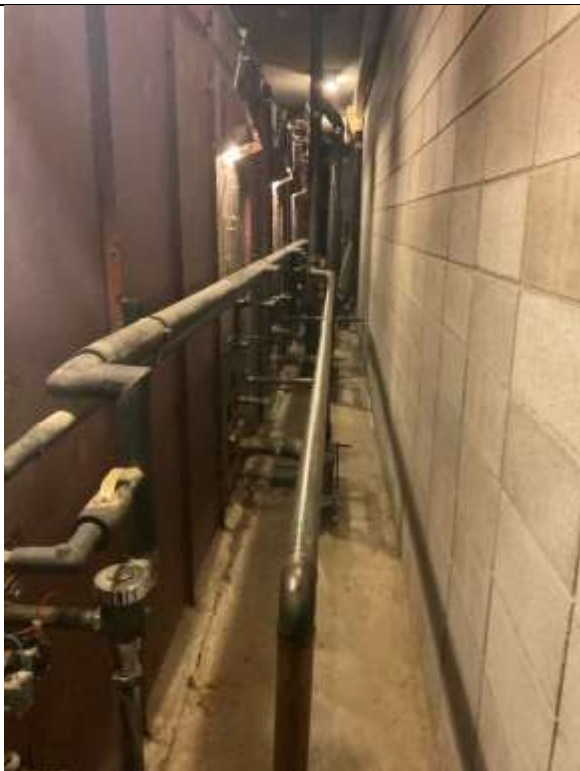
<p><b>Photo 4:</b></p> <p>2<sup>nd</sup> Floor East Housing pods, chase serving one pod. Limited room on edge to get back into chase but does involve less piping to step over.</p>

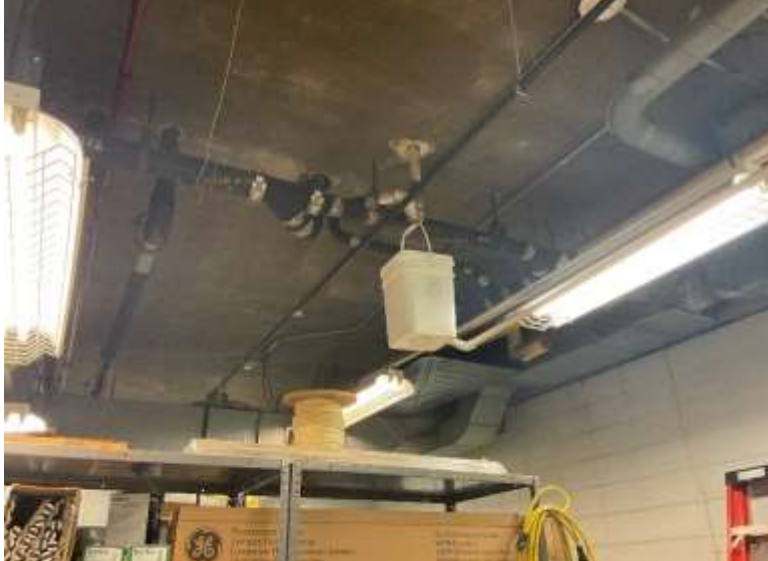
The domestic water piping located in the eastern portion of the building is original and in poor condition. While walking around in the maintenance area in the basement, buckets were observed to be hung above the ceiling to catch water from various pipe links. Puddles were also observed in multiple locations in the basement.

<p><b>Photo 5:</b></p> <p>Bucket hanging from ceiling to catch water from a leaky pipe.</p>

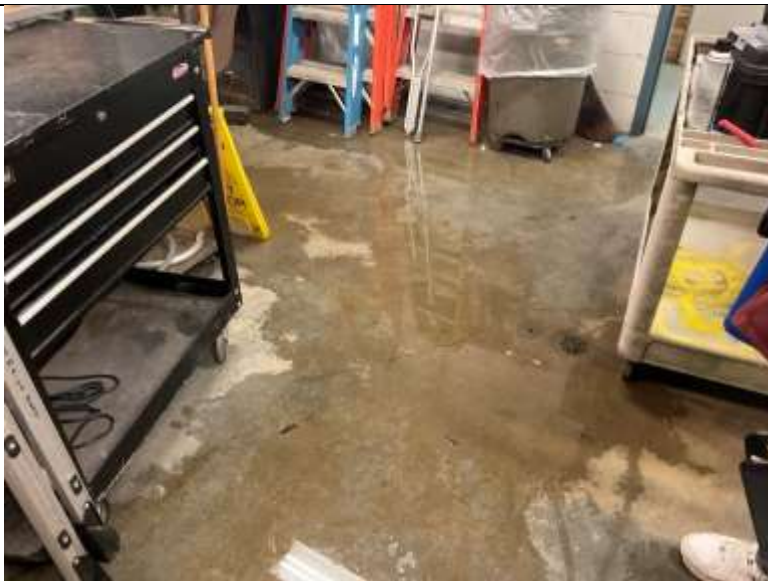
<p><b>Photo 6:</b></p> <p>Water on the floor in the basement Maintenance Shop due to leaking pipes.</p>

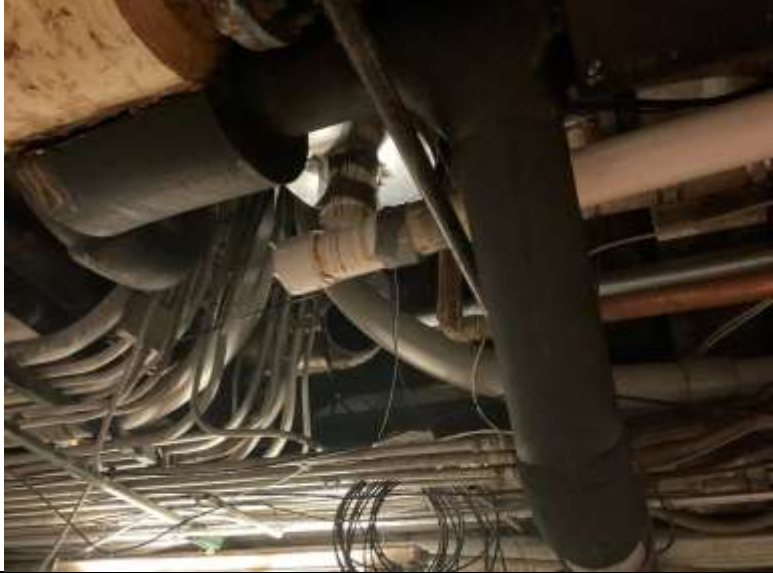
<p><b>Photo 7:</b></p> <p>Sanitary pipe fitting with duct tape for temporary fix where there was a leak.</p>

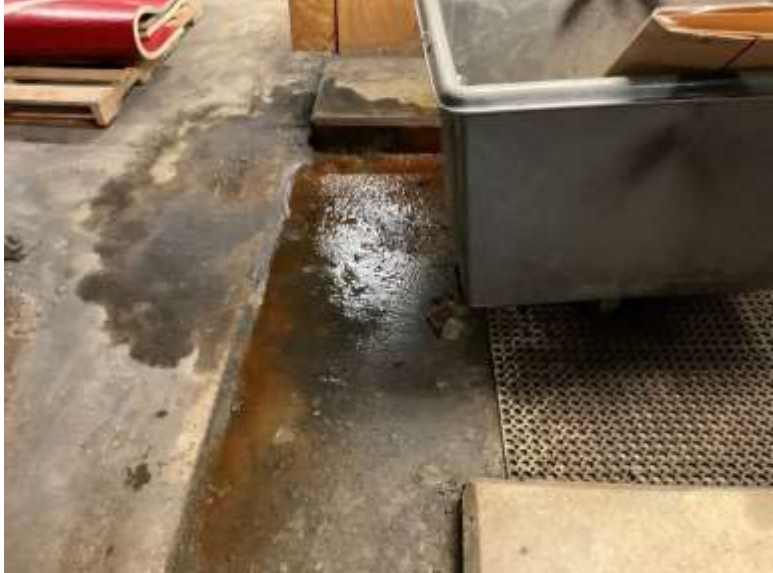
<p><b>Photo 8:</b></p> <p>Evidence of a pipe leak in the Basement Mechanical Room.</p>

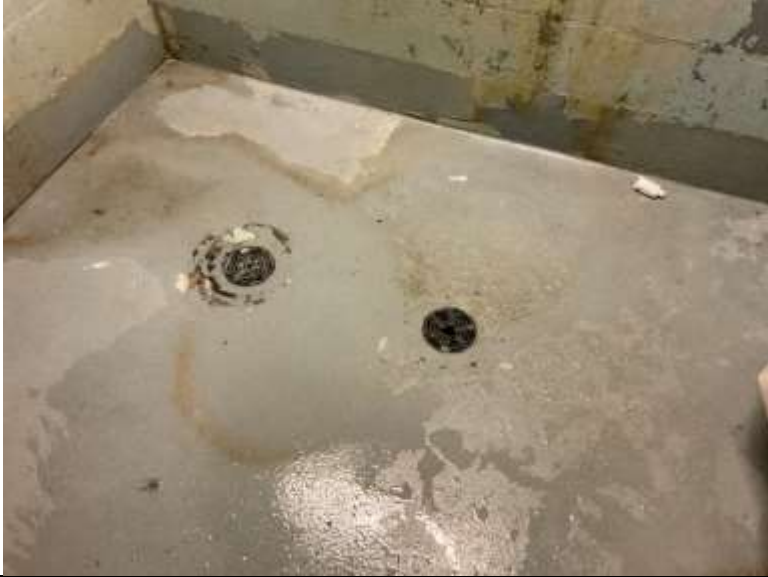
**Photo 13:**

2000 Renovation Housing Unit. Floor drains in shower in poor condition.

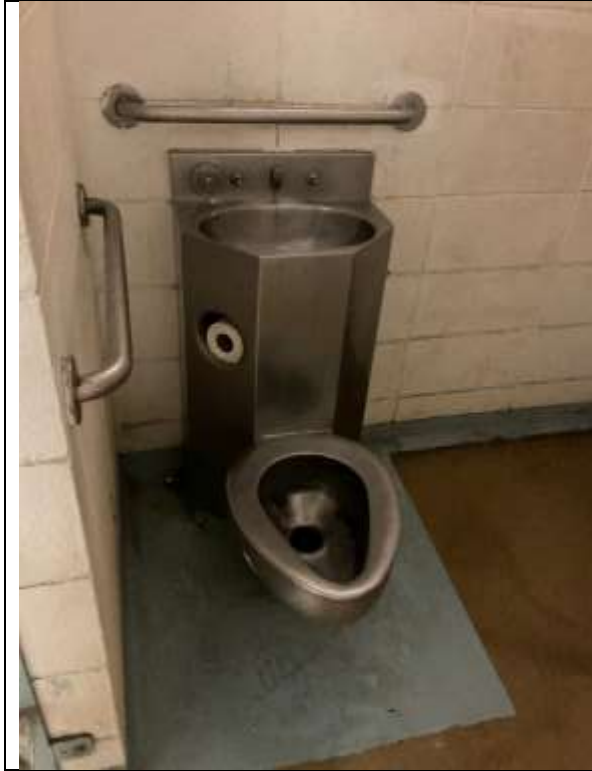
**Photo 17:**

Combination Unit in Intake/Booking. Unit in fair condition.

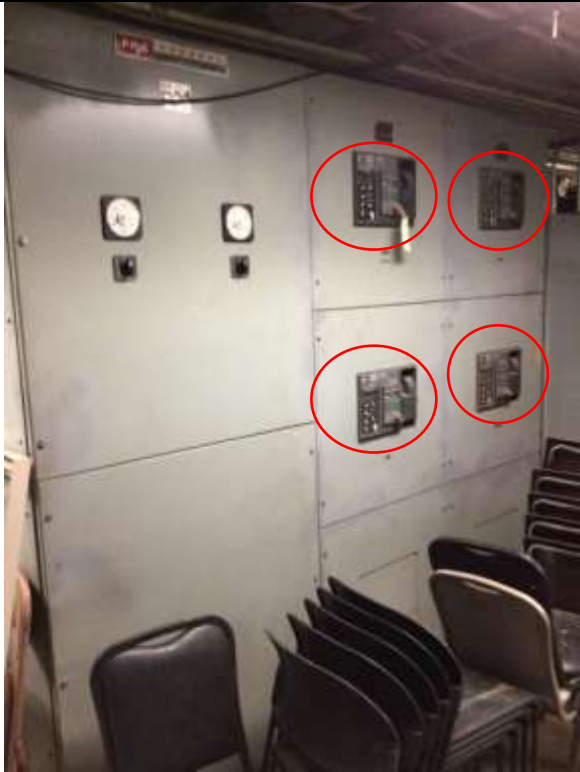
<p><b>Photo 1:</b></p> <p>Existing Federal Pacific Main Distribution Switchboard with four (4) Westinghouse service breakers.</p>

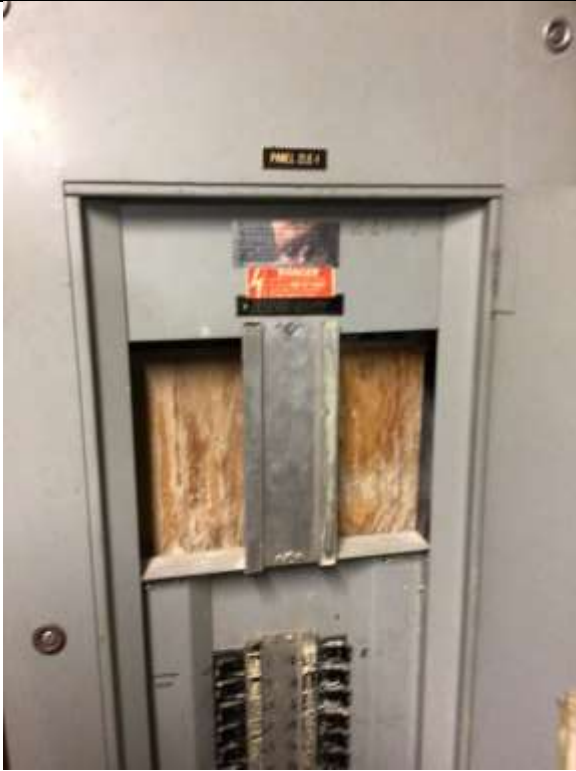
**Photo 2:**

Existing Panel '2LE-4'. Panel is showing signs of corrosion and is in violation of the NEC and OSHA as a piece of plywood has been installed behind the panel cover over the bus.

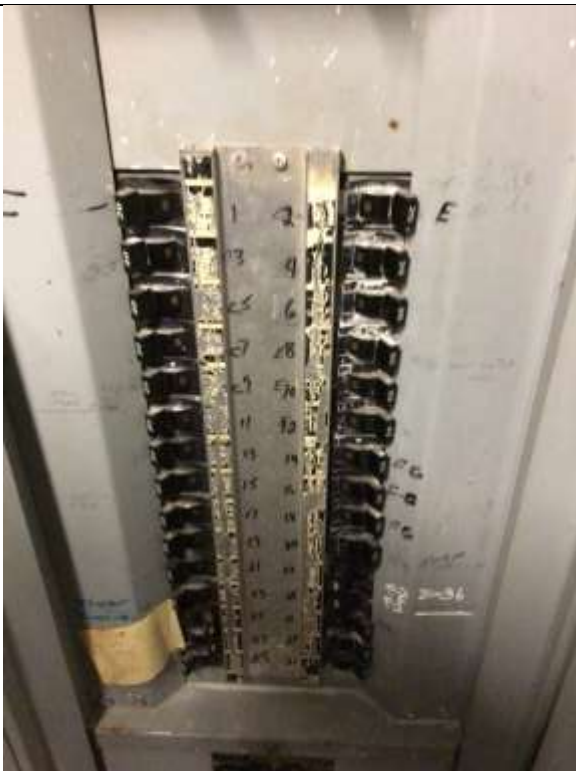
**Photo 3:**

Existing Panel '2LE-4' showing signs of corrosion around breakers.

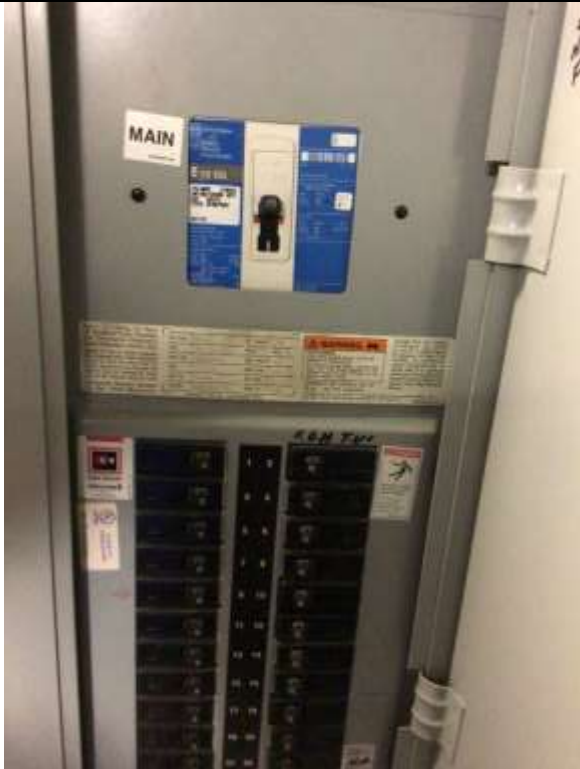
<p><b>Photo 4:</b></p> <p>Panel '2LE-2' with no issues.</p>

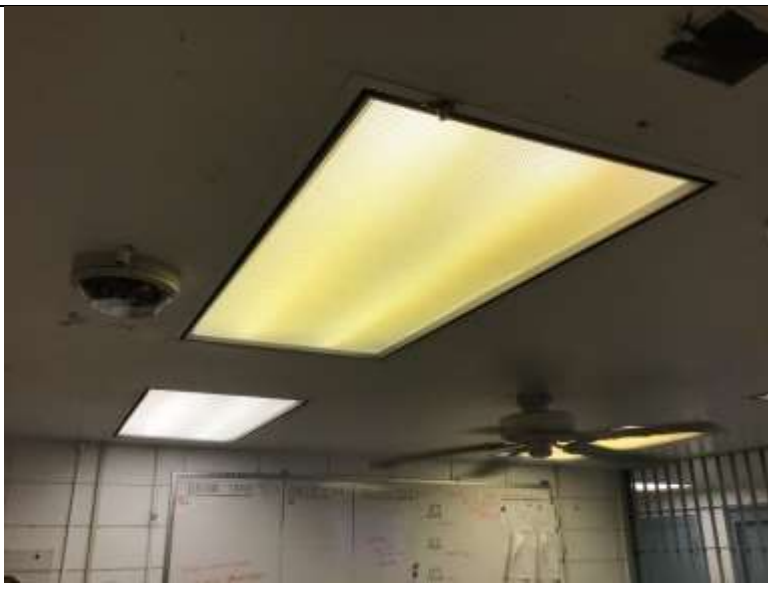
<p><b>Photo 10:</b></p> <p>Existing fluorescent acrylic troffer light fixtures in Intake Booking with different color temperature.</p>

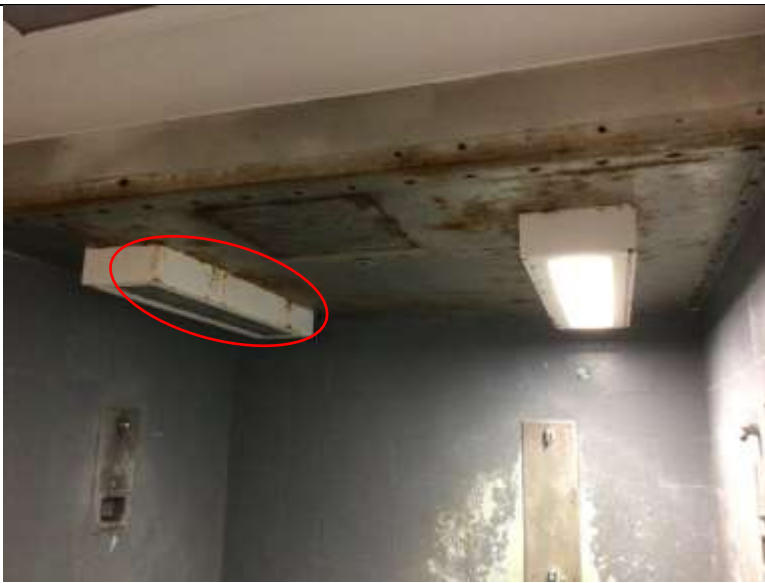
**Photo 14:**

Existing fluorescent Detention fixture showing signs of corrosion.

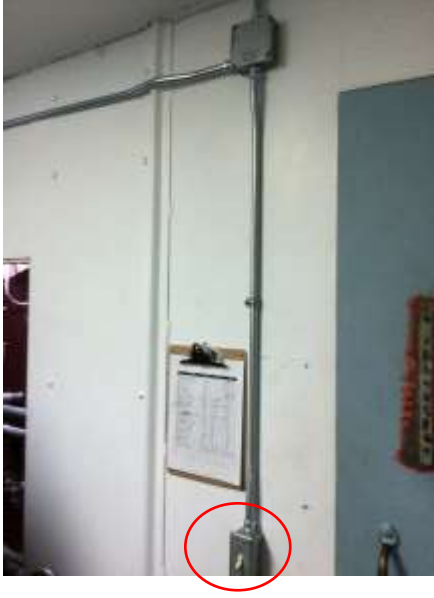
**Photo 21:**

Non-detention grade wiring device outside of Holding Cells.

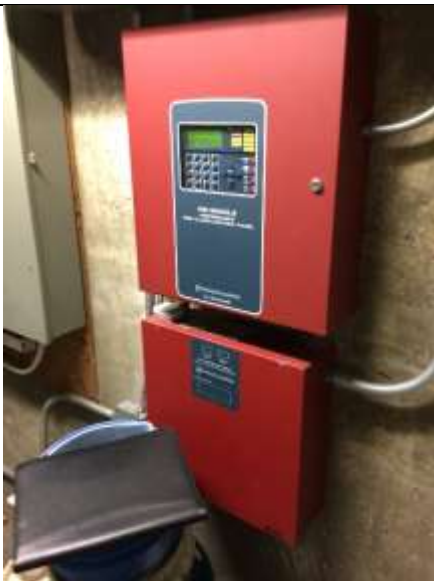
**Photo 22:**

Existing Fire-Lite #MS-9600LS Addressable Fire Alarm panel that was replaced after a lightning strike.

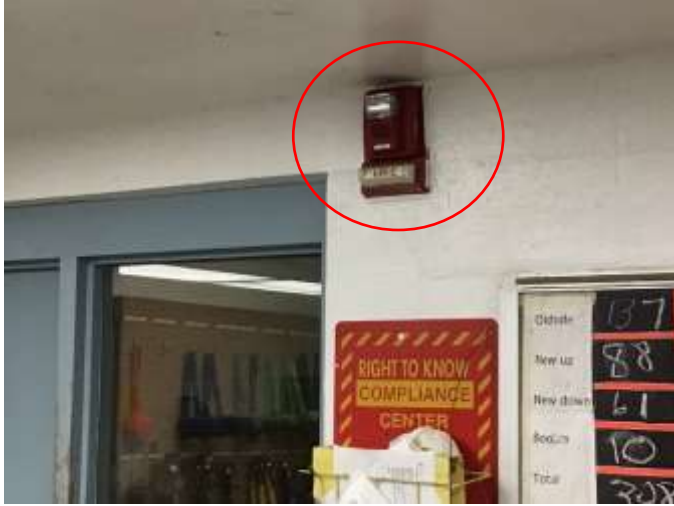
<p><b>Photo 23:</b></p> <p>Original 1979 Fire Alarm Horn/Strobe. NOTE: Device mounted at +94"</p>
