**APPENDIX D:**  
**Section 106 of the National Historic**  
**Preservation Act**

## Minor Projects PA Project Submittal and Assessment Form

**Project Description:** The project includes milling and resurfacing of North Clinton Street between Park and Imperial Avenues, 1.12 miles, as well as widening of North Clinton Street as required to expand the corridor to a three-lane section through the addition of a 12-foot continuous center two-way left-turn lane (TWLTL). The corridor would also include two 11-foot travel lanes, 4-foot paved shoulders with additional 4-foot paved mailbox approach (as required), and an 8-foot asphalt pedestrian path for pedestrians located on the east side of the roadway to be separated by a 10-foot grass buffer for the entire project length. A traffic signal will be installed on the east side of the intersection of Hasselburger Avenue and North Clinton Street, along with Americans with Disabilities Act (ADA) compliant curb ramps and pedestrian push button along the new trail. The additional improvements include pavement widening, HMA shoulder, and paved trail along the east side of Clinton Street extending to Imperial Avenue.

Red Flag Investigation - Si

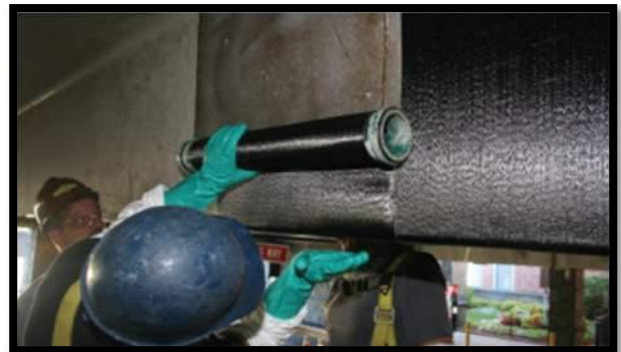
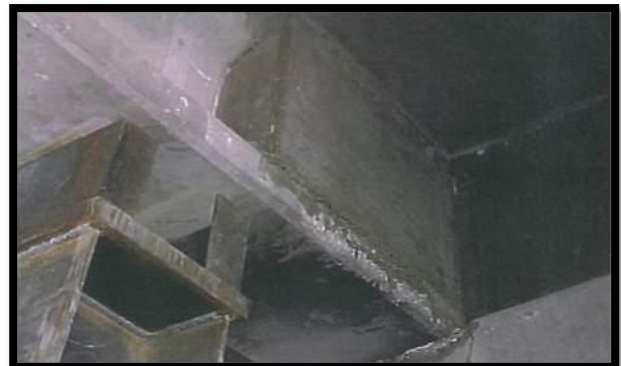
### **Beam End Encasement**

Another strategy would be to utilize a fiberwrap or Ultra High-Performance Concrete (UHPC) collar to provide a barrier for the embedded reinforcement and mitigate future crack development or propagation. This method would extend the service life of each beam by approximately 25 years and has been utilized by many Departments of Transportation. However, this method does introduce additional concerns. Use of either material does not guarantee that cracks will not continue to develop, and furthermore these encasements would prevent further observation and inspection of the cracks.

Repairs required to utilize beam end encasement would be more destructive than epoxy injection, requiring portions of the existing deck to be removed so that the wrap or encasement could be cast fully around the beam. With these other incidental repair items required by this method, these costs are estimated at \$305,000.

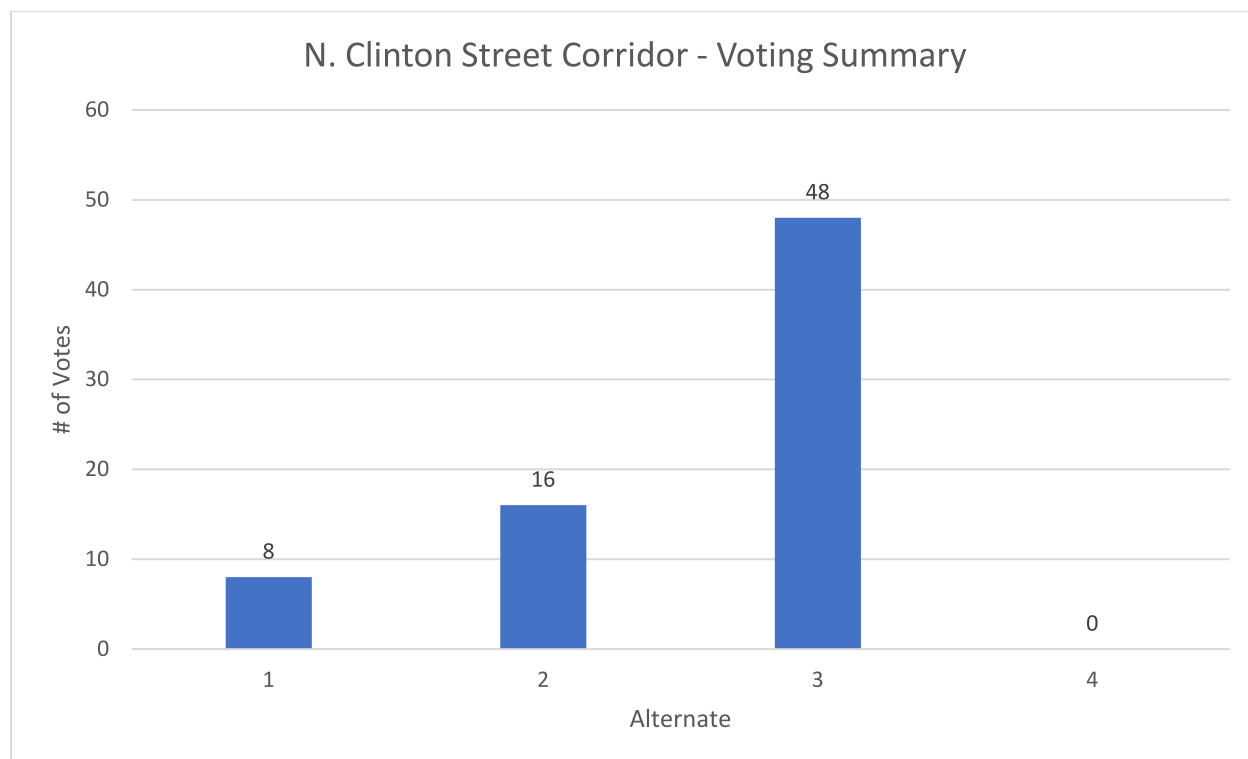
Additionally, a poll was provided on the landing page for members of the public to vote for their preferred alternate, as well as provide feedback or comments for their selection. A total of 72 individuals provided input to the poll, and the results are summarized in the figure below. A detailed breakdown of the received votes including comments has been provided in Appendix "J", but with any personal information such as names, addresses, or contact information omitted.

As illustrated, there was a strong show of support for Alternate 3, with many comments listing the proposed multi-use trail and safety of pedestrians as primary factors in their voting. Voters for Alternates 1 and 2 provided helpful comments as well, highlighting concerns of demand for and maintenance of the trail system and concerns about impacts to the residents along the east side of the corridor.
