# VIGO COUNTY SECURITY CENTER

*Repurpose Existing Facility Study*

May 25, 2022

DLZ Indiana, LLC (DLZ)  
2263.1082.90

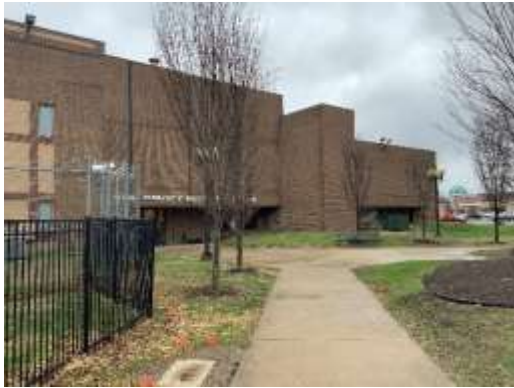
With the location of the main entrance into VCSC, it is difficult to visually see the entrance from the parking lot. It is also a long walk as there are no parking spaces near the entrance to VCSC.

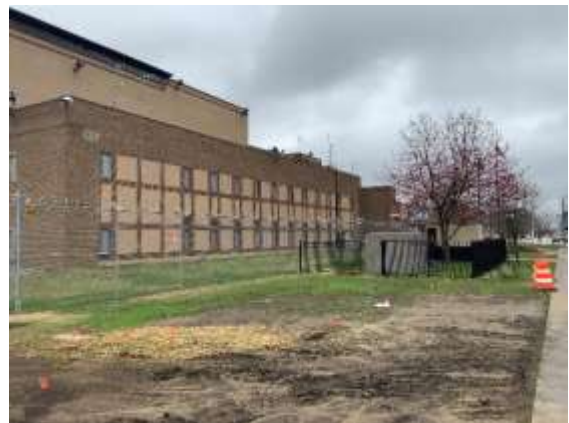
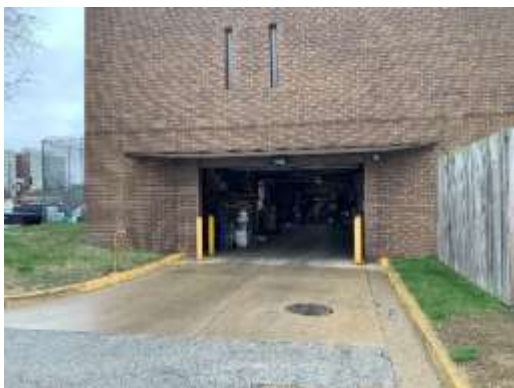
On the north side of the VCSC is parking dedicated to the staff. It is also the location of the vehicle sallyport. The intercom to the vehicle sallyport has rusted – two intercom heights should be explored. Slip covers should be provided at the bollards as the paint is in poor condition.

The wood fencing to screen the mechanical equipment is in poor condition.

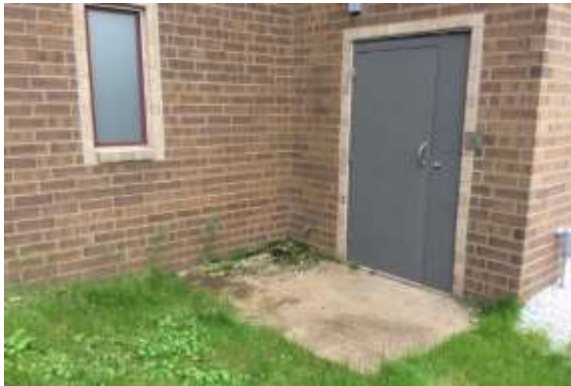
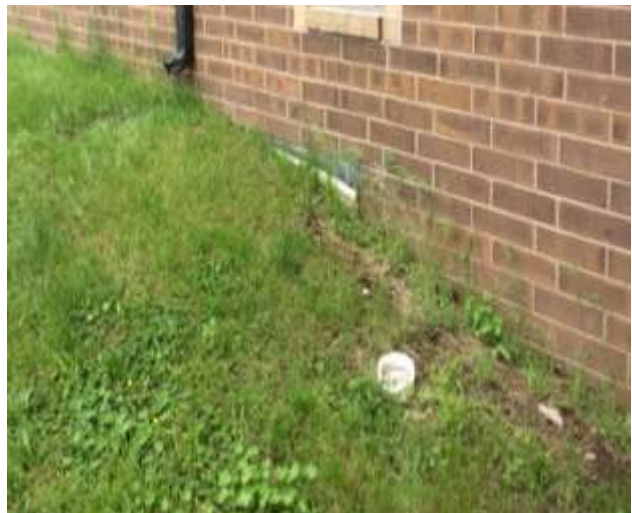
The lack of splash blocks at the bottom of downspouts has created erosion. The erosion could cause possible foundation settlement issues.

Several of the required exits need to have concrete walks extended to public right-of-ways.

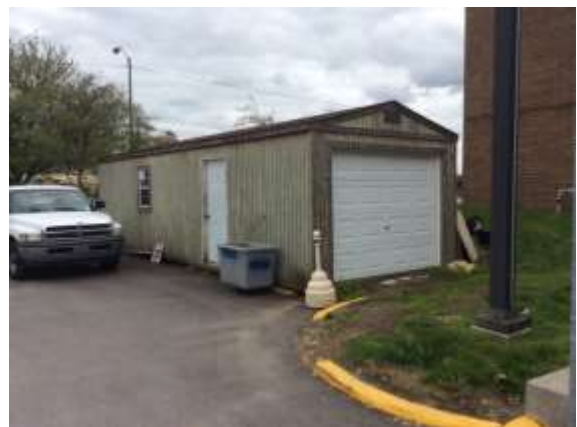
The storage barn is in poor condition. Additional storage is required.

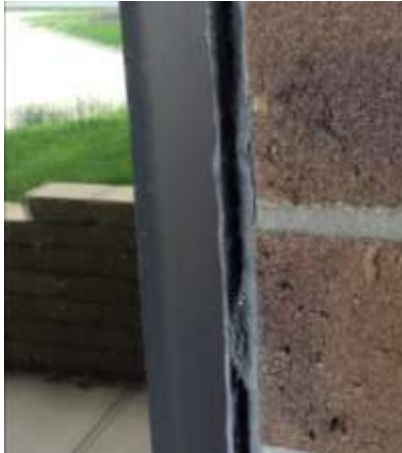
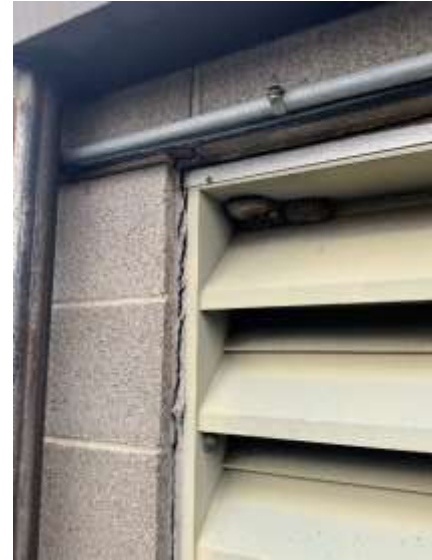
Most of the sealants are in poor condition. They have failed, cracked, and separated from the materials they are sealing. Replacing exterior sealants before they fail is one of the most important contributors to maintaining a healthy building envelope. An estimated 90 per cent of air and water leakage occurs at one per cent of a building's sealant locations (vulnerable sites such as

The exterior windows and door systems are in fair condition. There are both commercial grade and detention grade openings around the building, pending the location and internal use. Some windows are showing signs of surface rust.

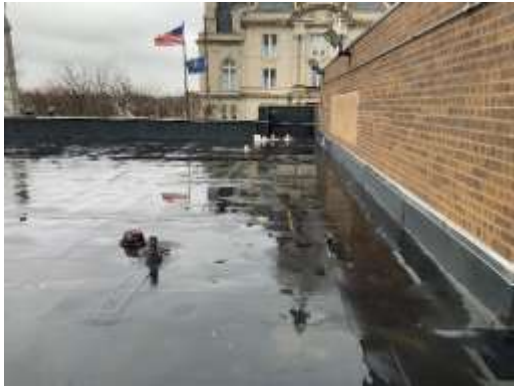
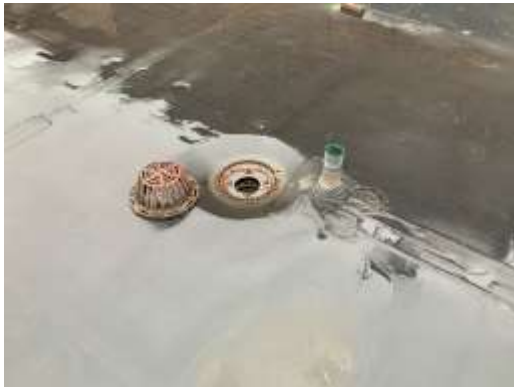
Tapered insulation typically provides the low slope for drainage. The tapered insulation system slopes at approximately  $\frac{1}{4}$ " per foot to area roof drains. Strainers are provided at each roof drain – some strainers are broken or missing. Per the current building code, at each location there should be a roof drain and an overflow drain (basically a 2" trim around the drain) – overflow drains are not present. The roof drains are then piped internally through the building to an underground stormwater collection.

There are several areas on the roof system where ponding water occurs. Ponding water is defined as the water which remains on a roof 48 hours or longer. Water may accumulate on a low-slope roof due to rain, snow, or runoff from rooftop equipment. Ponding water can have major negative consequences, regardless of the type of roofing system. Proper design, installation and maintenance of roofing structures can prevent this condition and its associated problems.

Overall, the roofing system appears to be in fair condition, but replacement should be considered with a full renovation and repurposing of the facility.

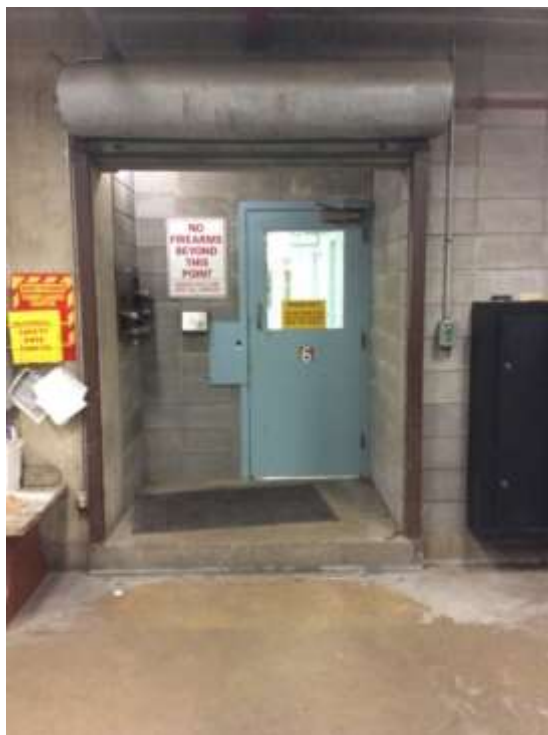
The intake area is not ADA compliant due to the step into the area. An ADA compliant ramp is required.

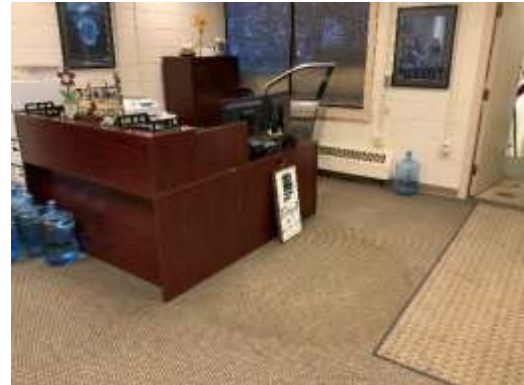
Overall, the Jail side of the facility is in poor condition. Typical of Indiana jails, floors are concrete, walls are painted, and a variety of ceiling types. Due to the area being used by inmates 24/7 for the past several decades, the finishes need to be fully renovated if repurposed.

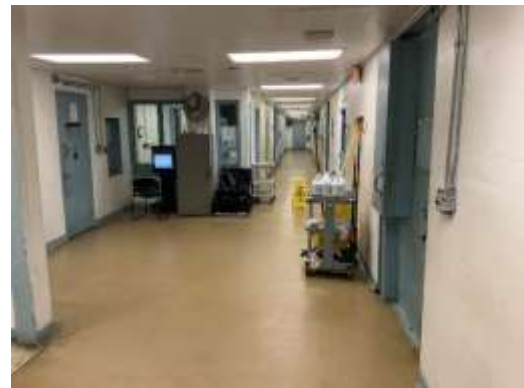
The lower level finishes are in fair to poor condition, pending the area. The toilet rooms need to be updated, while the Training Room is fair and the 911 Dispatch area is fair. Storage areas and evidence processing areas are typical of other facilities.

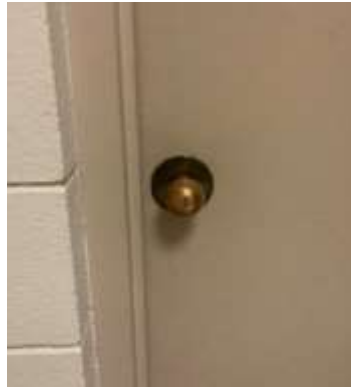
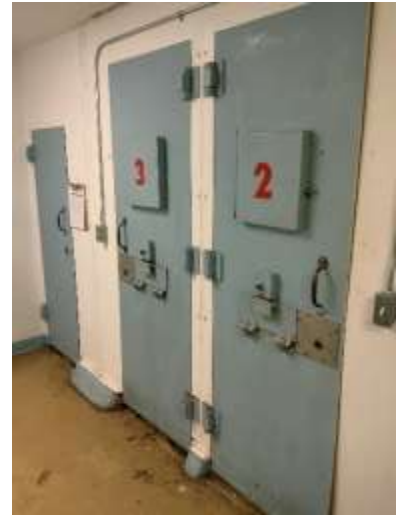
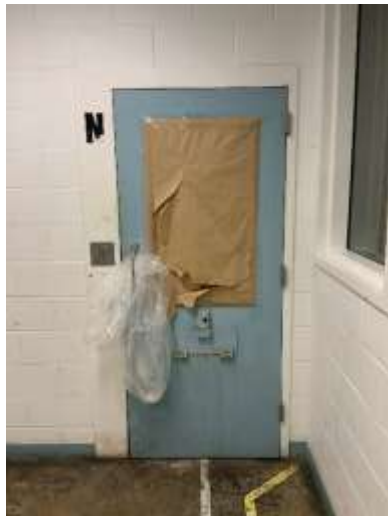
Doors are in fair condition, but they should be painted or refinished. There are hollow metal frames showing rust at the bottom due to continual floor mopping and the possibility of accelerates used when originally grouting the frames solid.

Not all door hardware is fully compliant with ADA requirements. Doorknobs in lieu of levers are used at several locations.

Door hardware is old and, in several areas, should be upgraded or replaced. Many doors have hardware that must be retrofitted in lieu of replacement, due to the age of the hardware and availability of replacement parts.

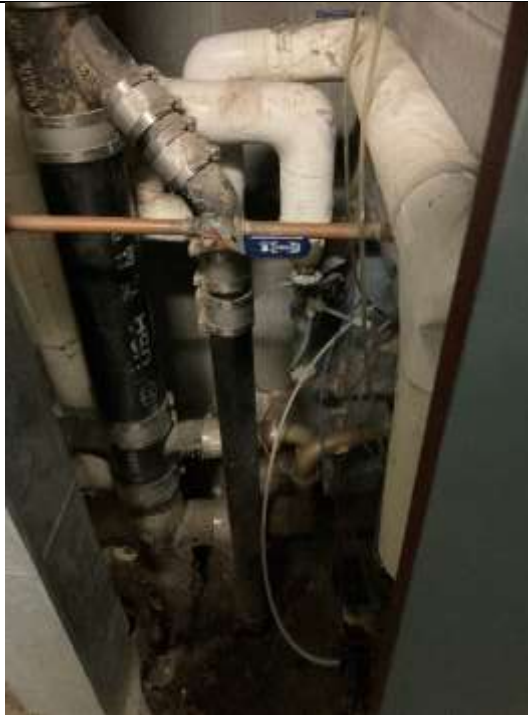
<p><b>Photo 2:</b></p> <p>Chase in 2000 Renovation Housing Pods. Chase has more piping, ductwork, etc. and is more difficult to maintain.</p>

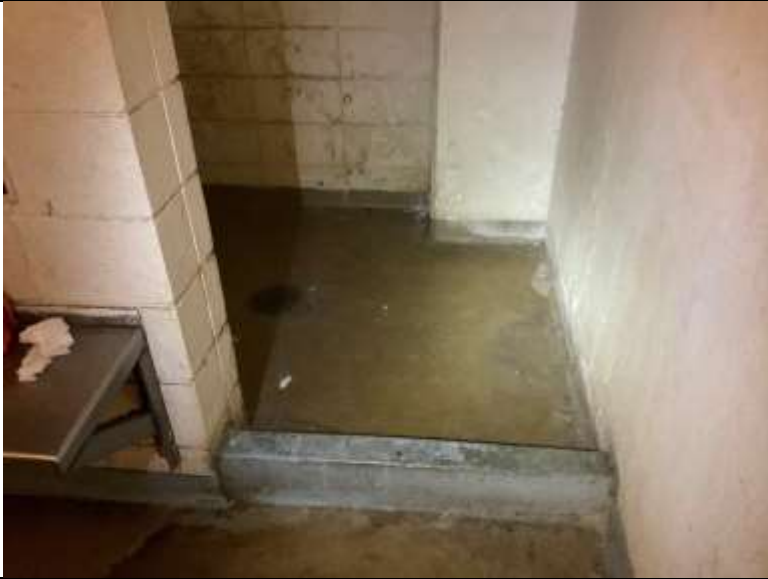
**Photo 9:**

Intake/Booking Shower with water in the basin. Sanitary pipe is clogged. This was part of the issue that happened at 3 AM prior to the site visit.

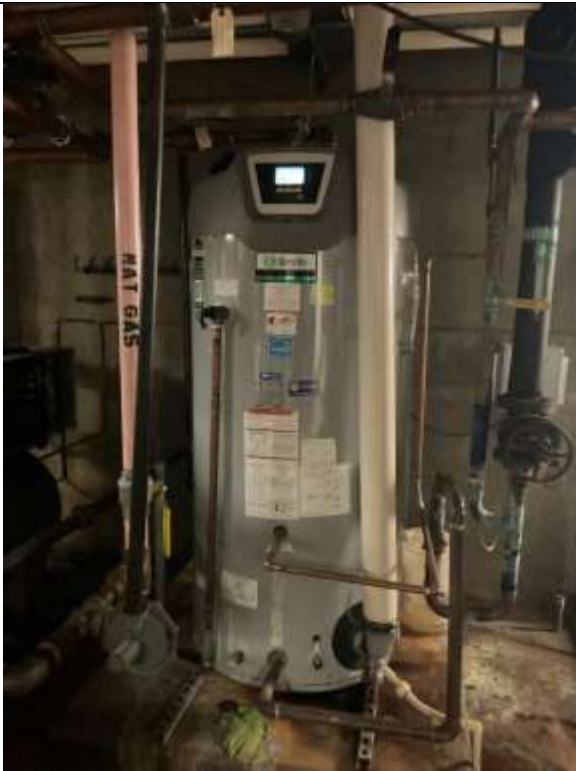
**Photo 10:**

New water heater in Basement Mechanical Room.

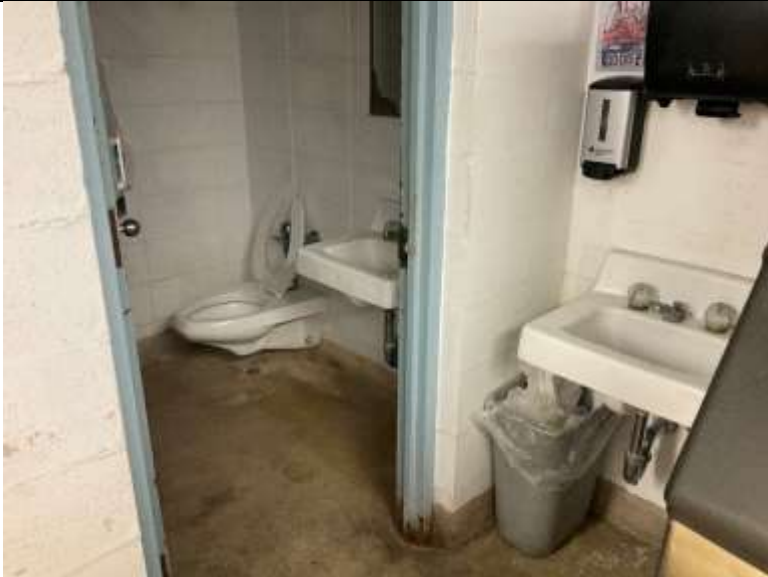
**Photo 14:**

Typical fixtures in staff restroom areas.

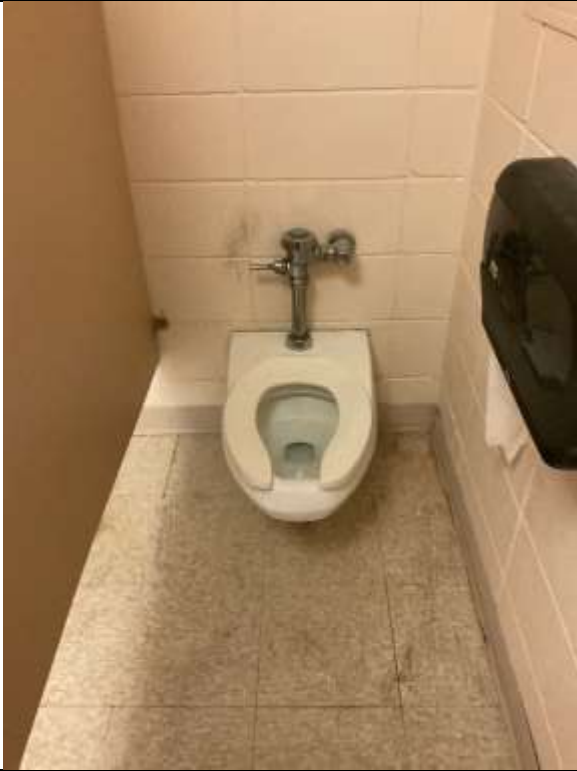
**Photo 15:**

Typical fixtures in public restrooms.

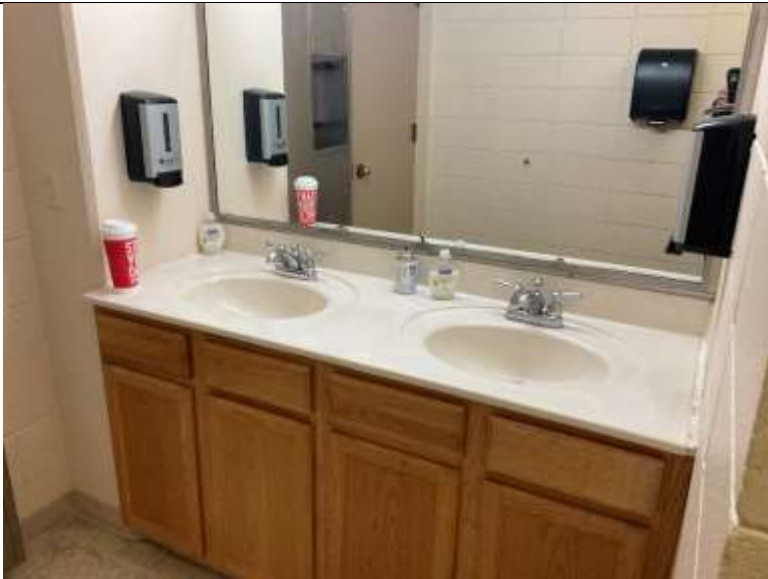
**Photo 16:**

Typical sinks in public restrooms.

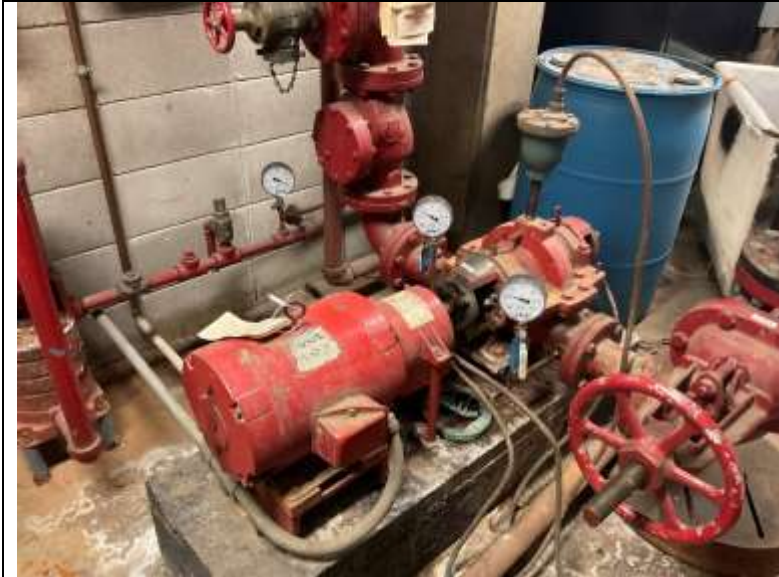
**Photo 1:**

Fire Pump in Basement Mechanical Room.

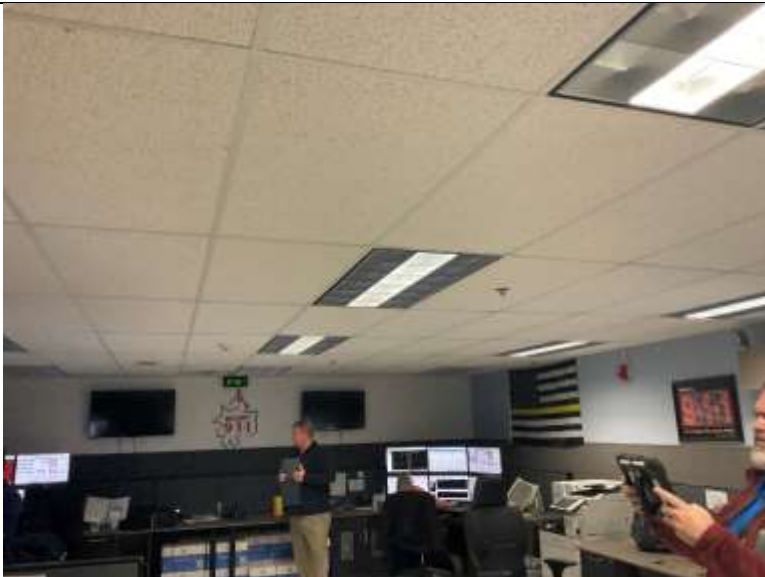
**Photo 2:**

Sprinkler heads in Dispatch Area.

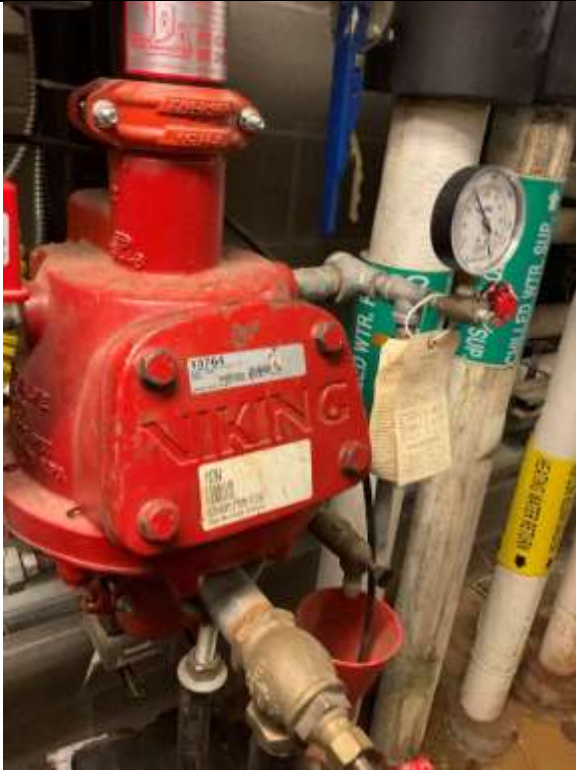
**Photo 3:**

Dry Pipe system serving the Recreation/Gym Area on the 3<sup>rd</sup> Floor.

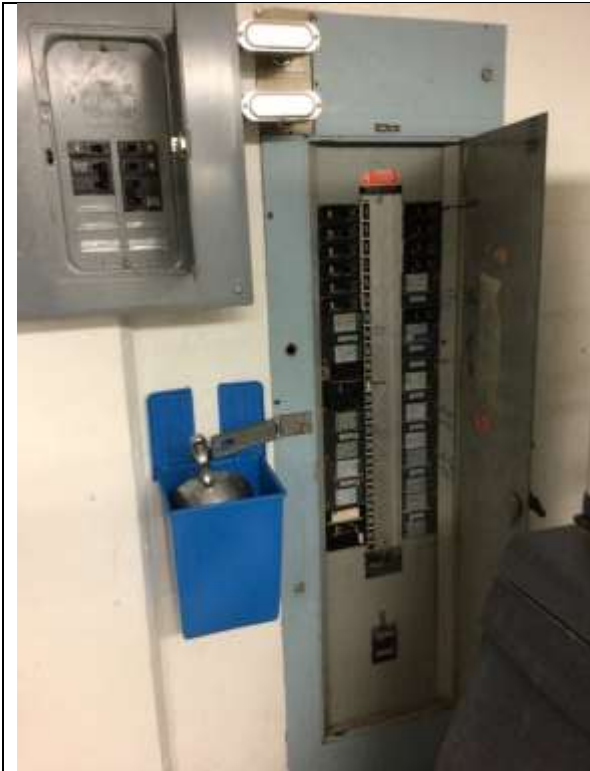
**Photo 5:**

Existing original 1979 Kitchen panel using different manufacturers (Federal Pacific and Westinghouse) products potentially violating the panelboard UL listing.

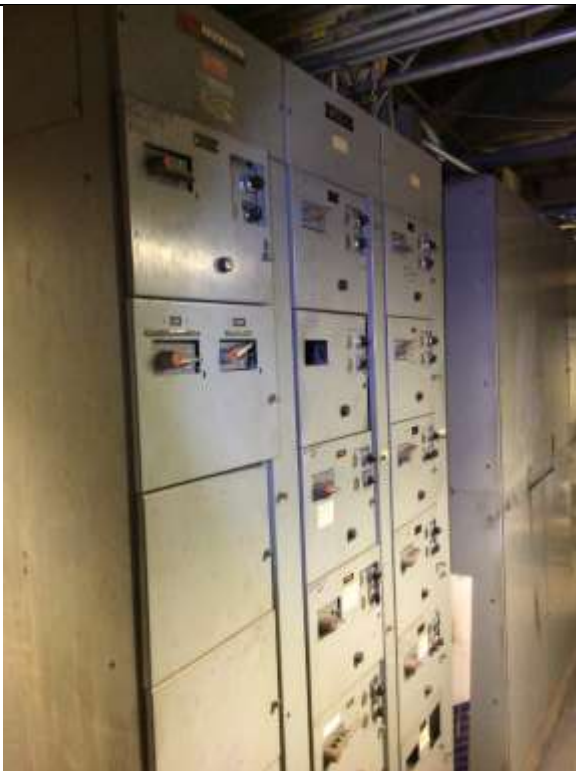
**Photo 6:**

Existing Federal Pacific #5320 Motor Control Center.

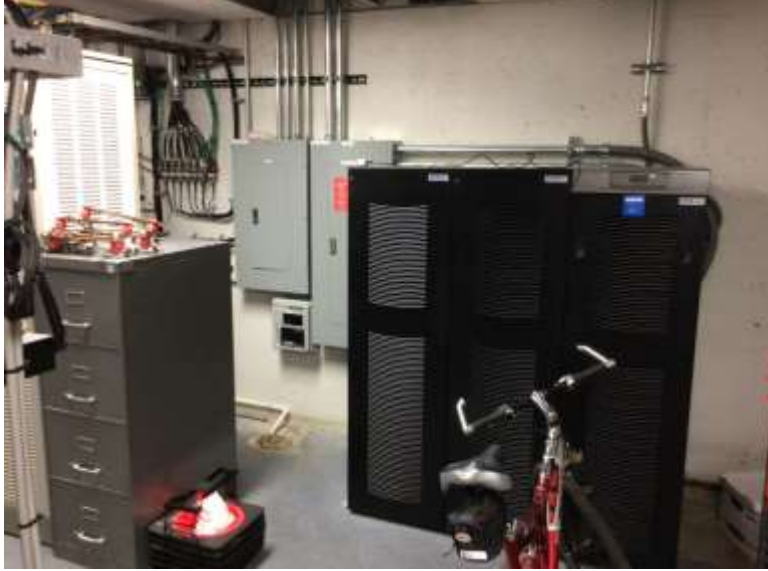
<p><b>Photo 9:</b></p> <p>Existing 911/Dispatch Eaton #9355 Uninterruptible Power Supply.</p>

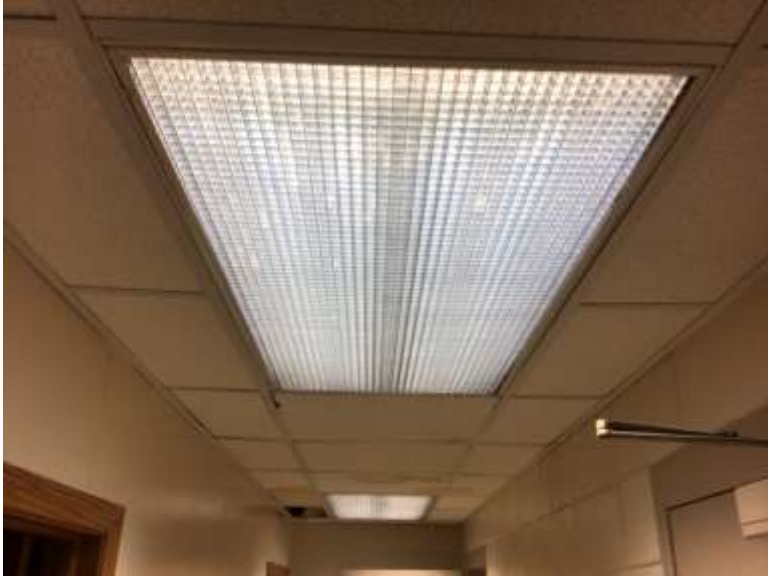
**Photo 11:**

Existing fluorescent cubed troffer light fixture in Admin Area.

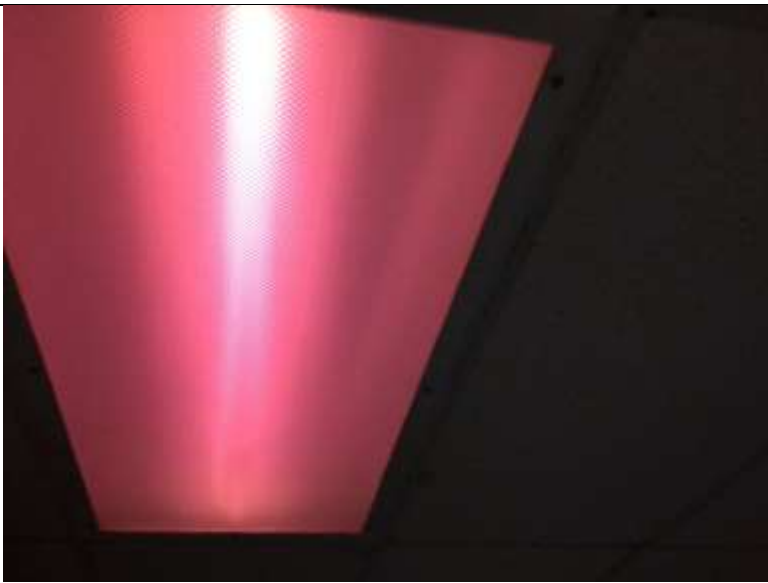
**Photo 12:**

Existing fluorescent acrylic troffer light fixtures in Detention Area Interlocks.

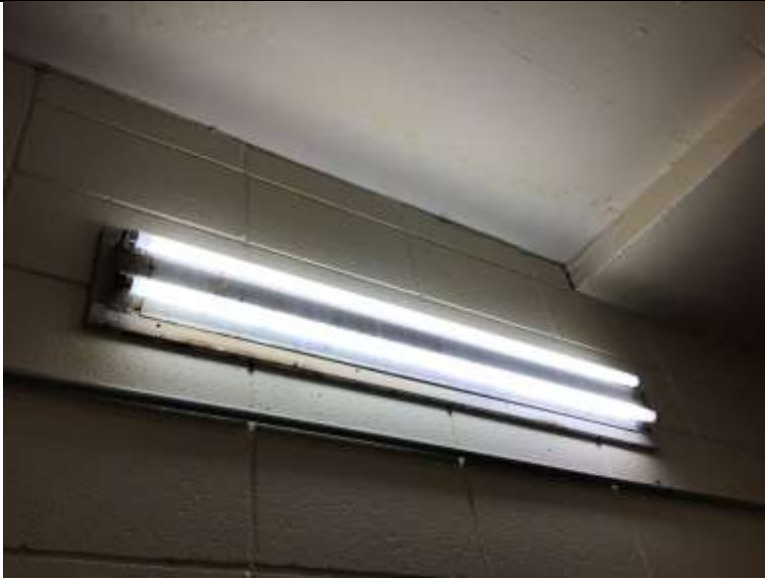
**Photo 13:**

Existing fixture base from past light fixture. Base is located in area around inmate housing.

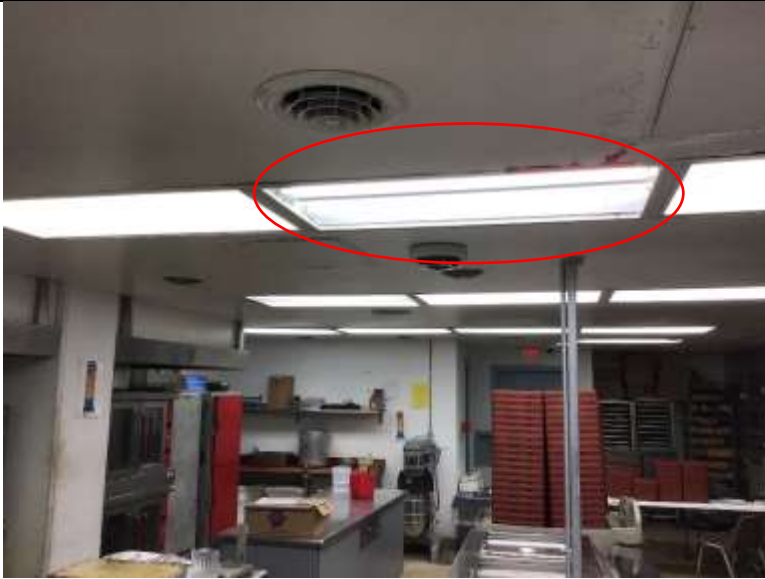
**Photo 15:**

Existing fluorescent light fixtures in Kitchen area without lens.

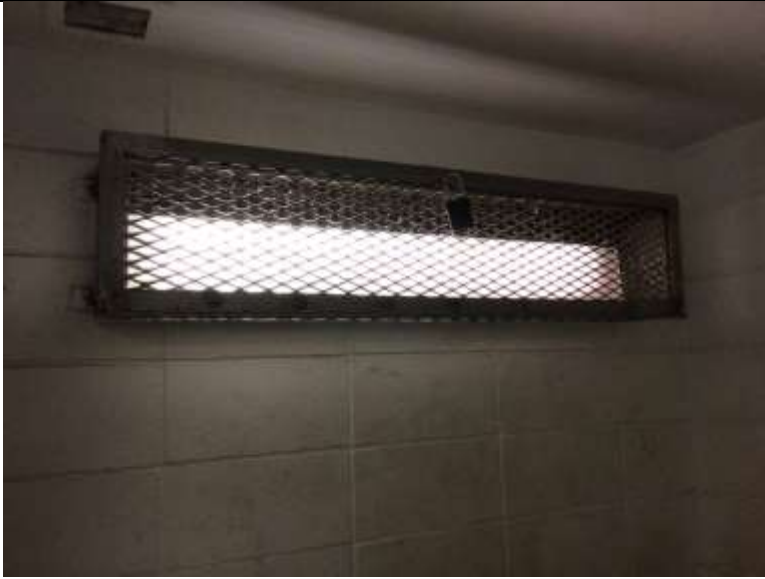
**Photo 16:**

Existing chase at Holding cells where light fixtures were added to provide additional lighting levels in cells.

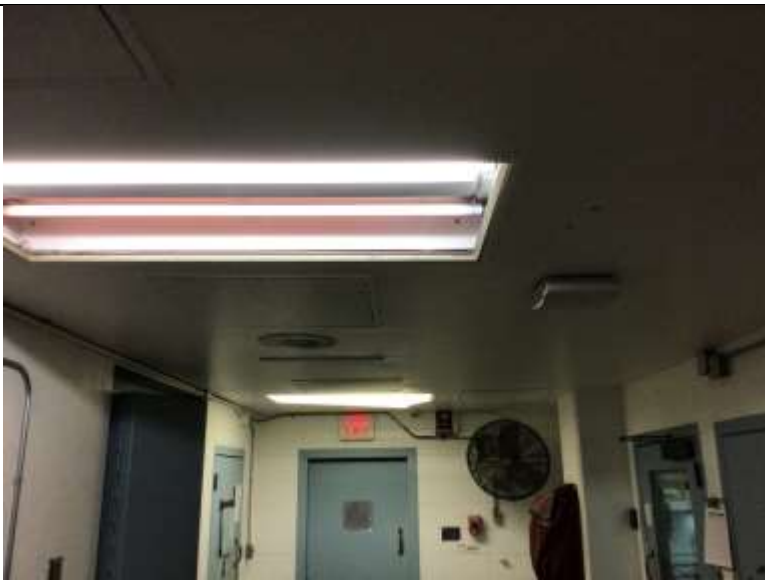
**Photo 17:**

Existing light fixture with custom metal cage and padlock.

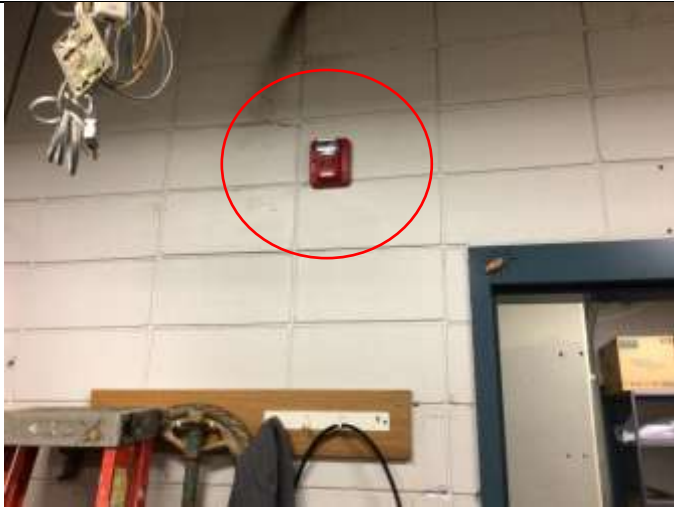
The current initiation and annunciation devices are a mix of original 1979 and current 2019/2020 devices. The original 1979 devices need replacement as they are beyond life expectancy. Additionally, all strobes may not be synchronized as they are of varying vintage and manufacturer which is a code violation (NFPA 72).

<p><b>Photo 23:</b></p> <p>Original 1979 Fire Alarm Horn/Strobe. NOTE: Device mounted at +94"</p>
